2016 International Conference on Alkali-silica Reaction
July 3-7, 2016

DIAGNOSIS OF ALKALI-SILICA REACTION IN AIRPORT PAVEMENT IN JAPAN

Naoya KAWAMURA

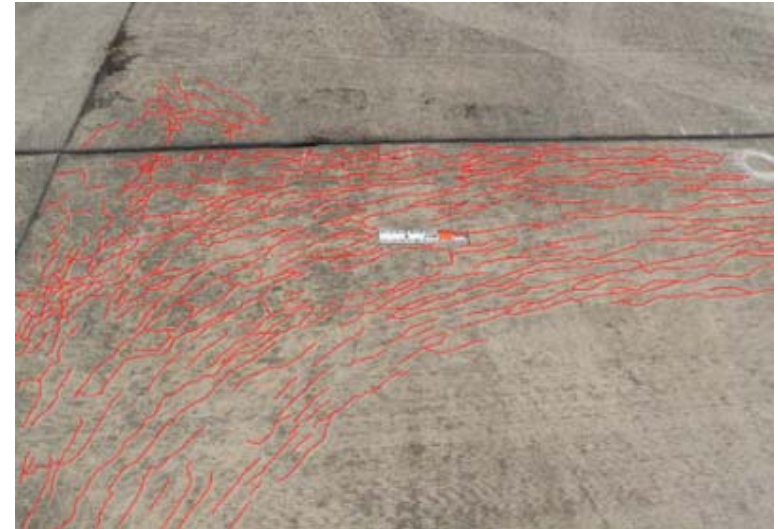
- ASR was identified in an pavement area (Deicers are not used)
- Surface cracks were observed in 40% of the pavement slabs
 - No freezing and thawing
 - Few repeated loadings
- Cores were sampled from both sound and cracked pavement slabs

D-cracking due to ASR

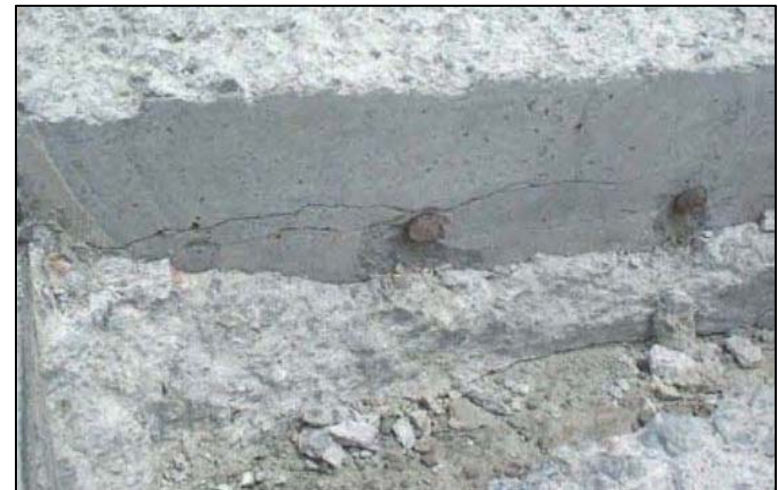
Cross-section of cracked pavement

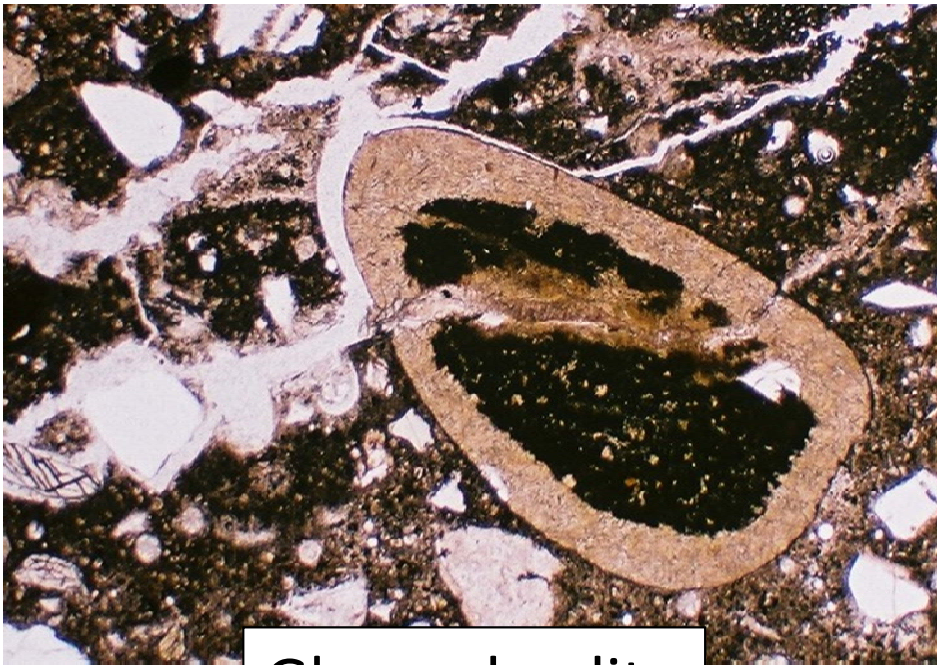
Glassy rhyolite

- ASR was identified in fine aggregates containing rhyolite with **volcanic glass** and mudstone with **opal**

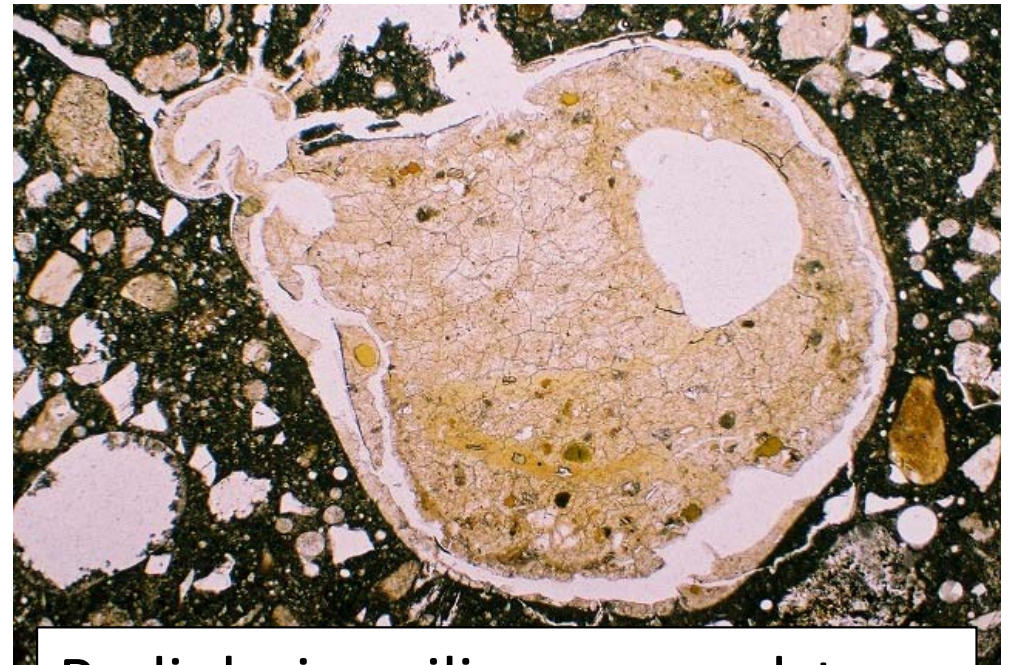
Radiolarian siliceous mudstone

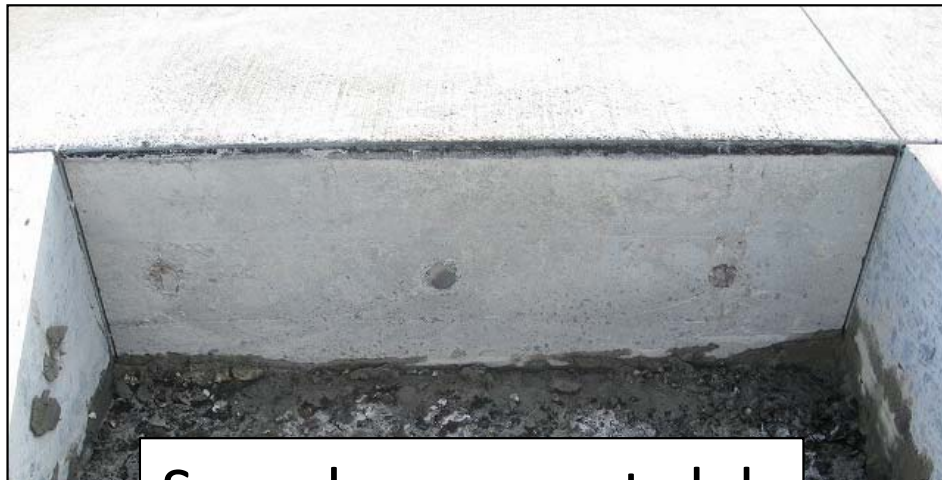
Sound pavement slab

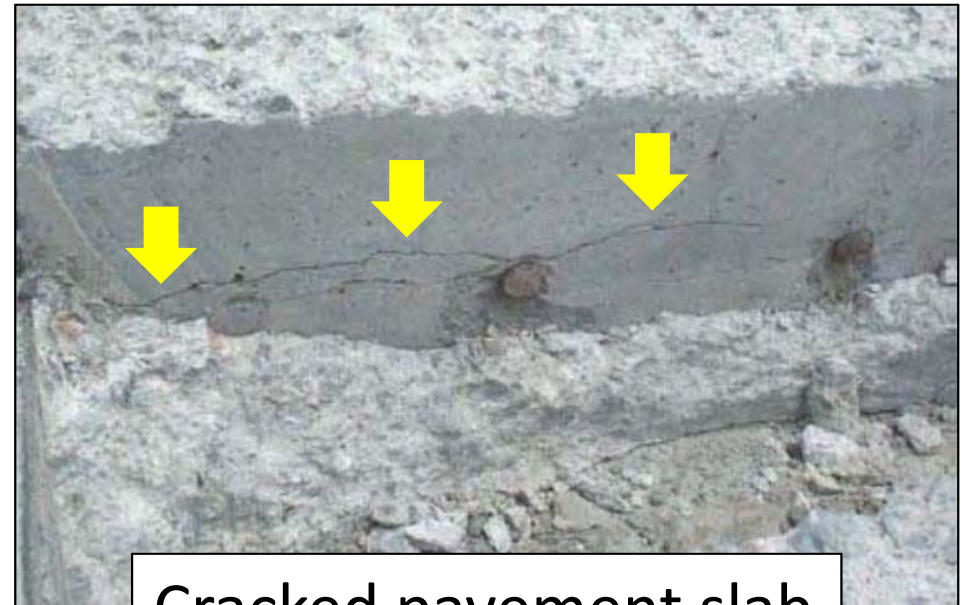
Cracked pavement slab

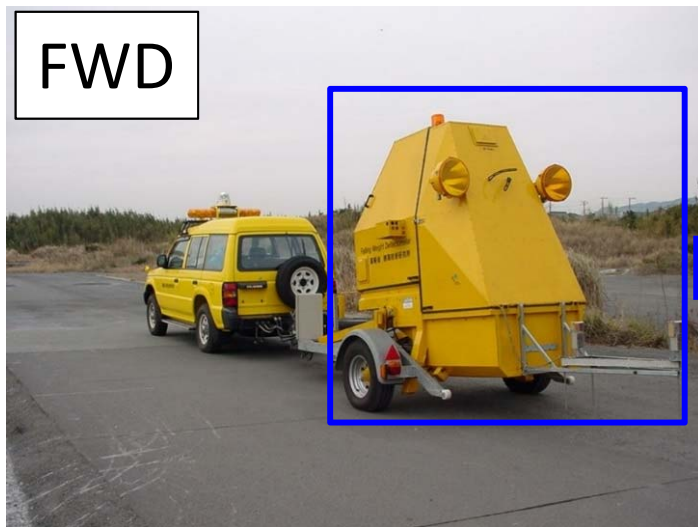
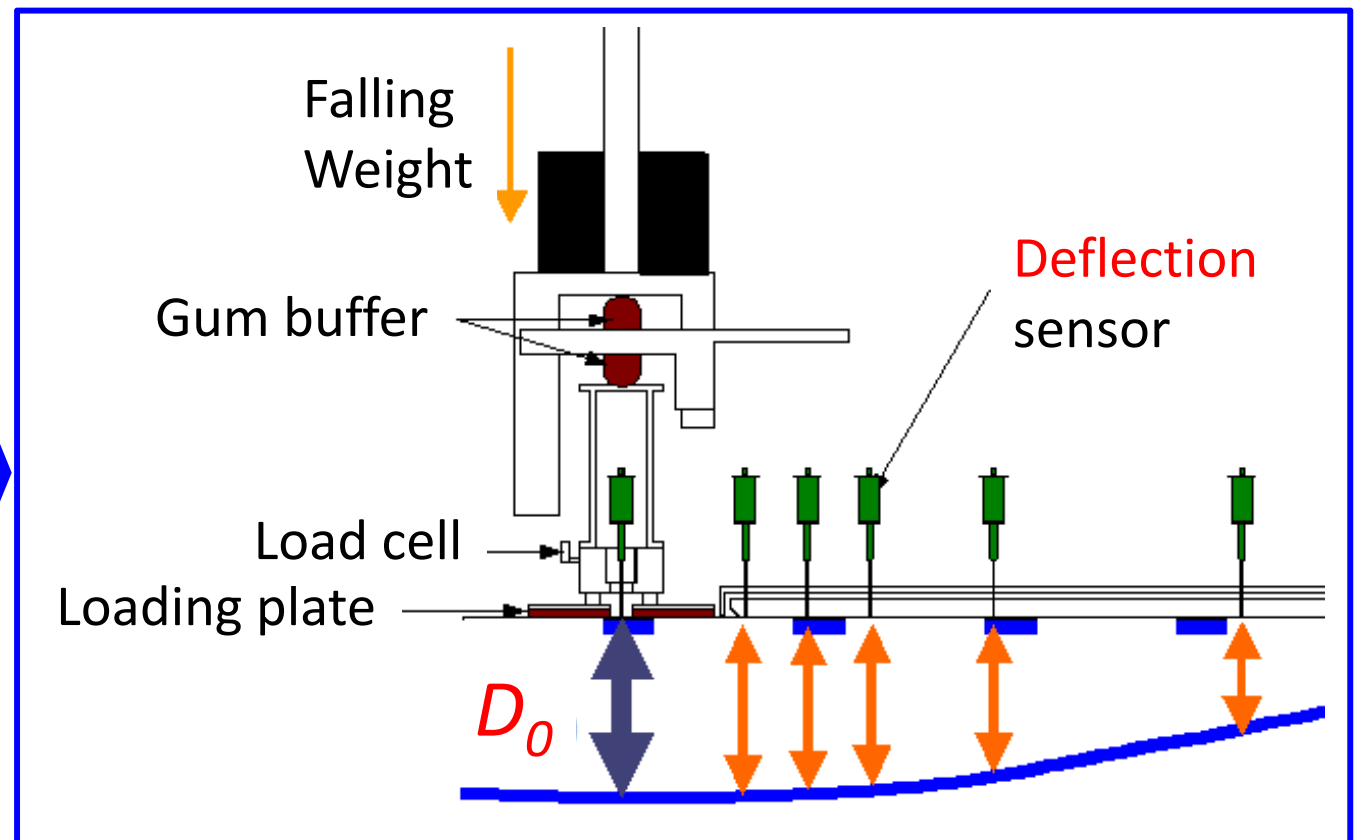
FWD test in the airport

- We evaluated the performance of cracked and sound pavements by **Falling Weight Deflectometer (FWD)**
- FWD is commonly used to evaluate structural performance in airport

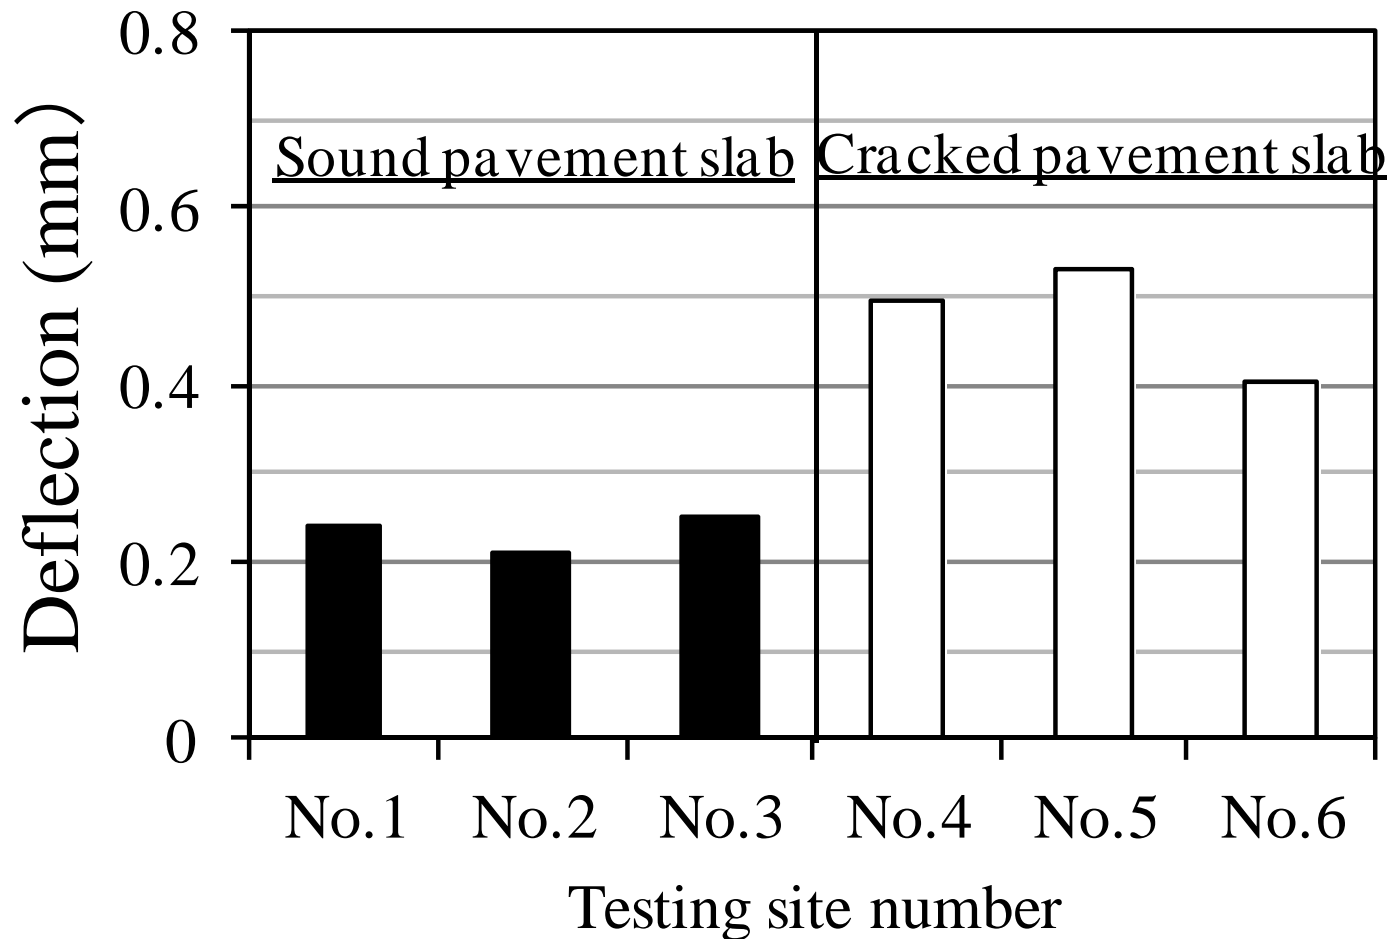
Test results

- Deflection of cracked pavement was twice larger.
- FWD could evaluate the performance of the affected pavement

- FWD could be a promising tool for evaluating the performance of ASR-affected pavement

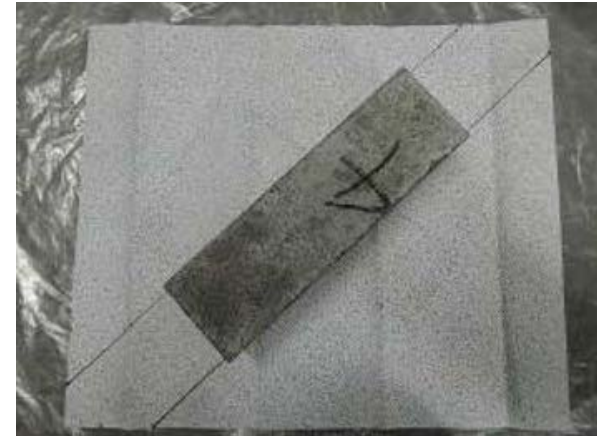
Wet cloth containing alkali solution

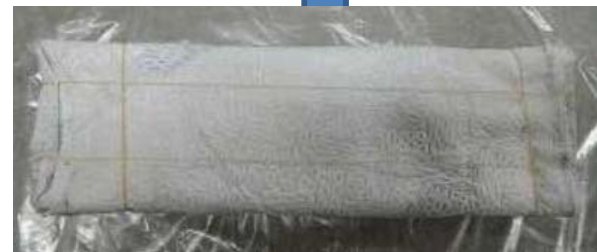
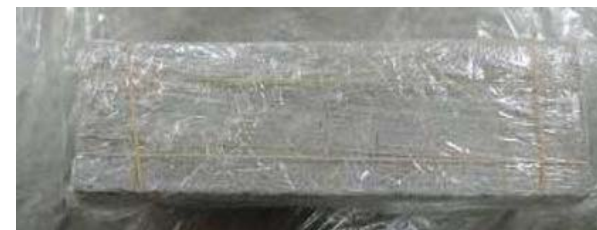
Covered by thin plastic film to avoid drying

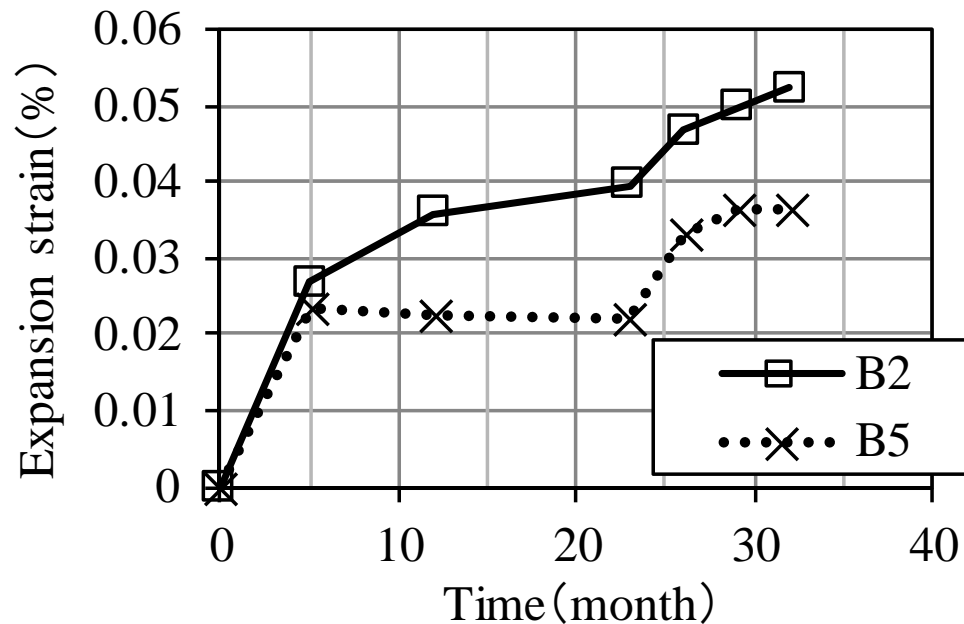
Field expansion

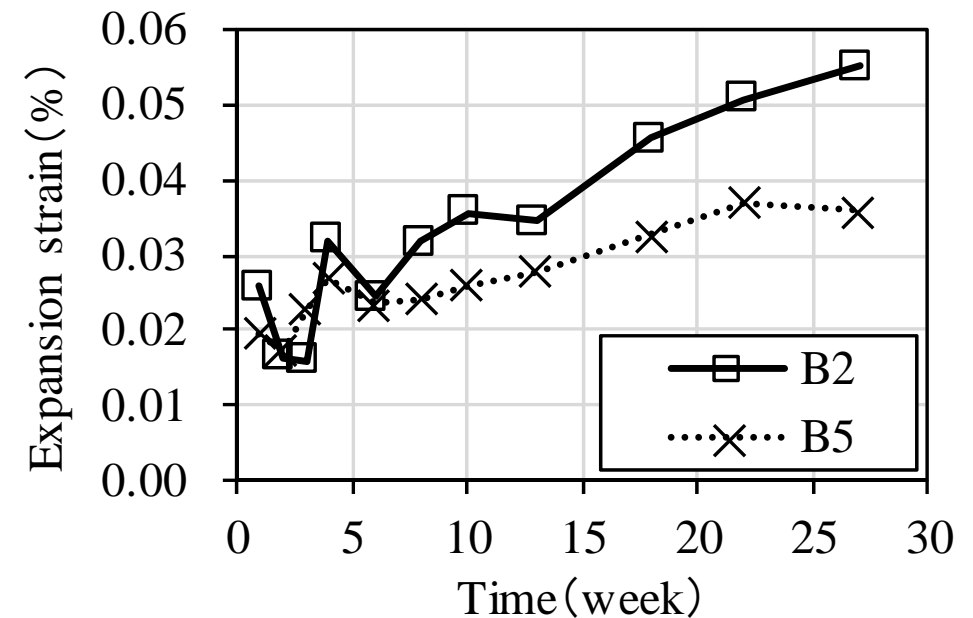
Expansion test

- Expansion test with AW **can simulate sustained expansion behaviour** shown in the field.

- Expansion test with AW can simulate the sustained expansion behaviour shown in the field

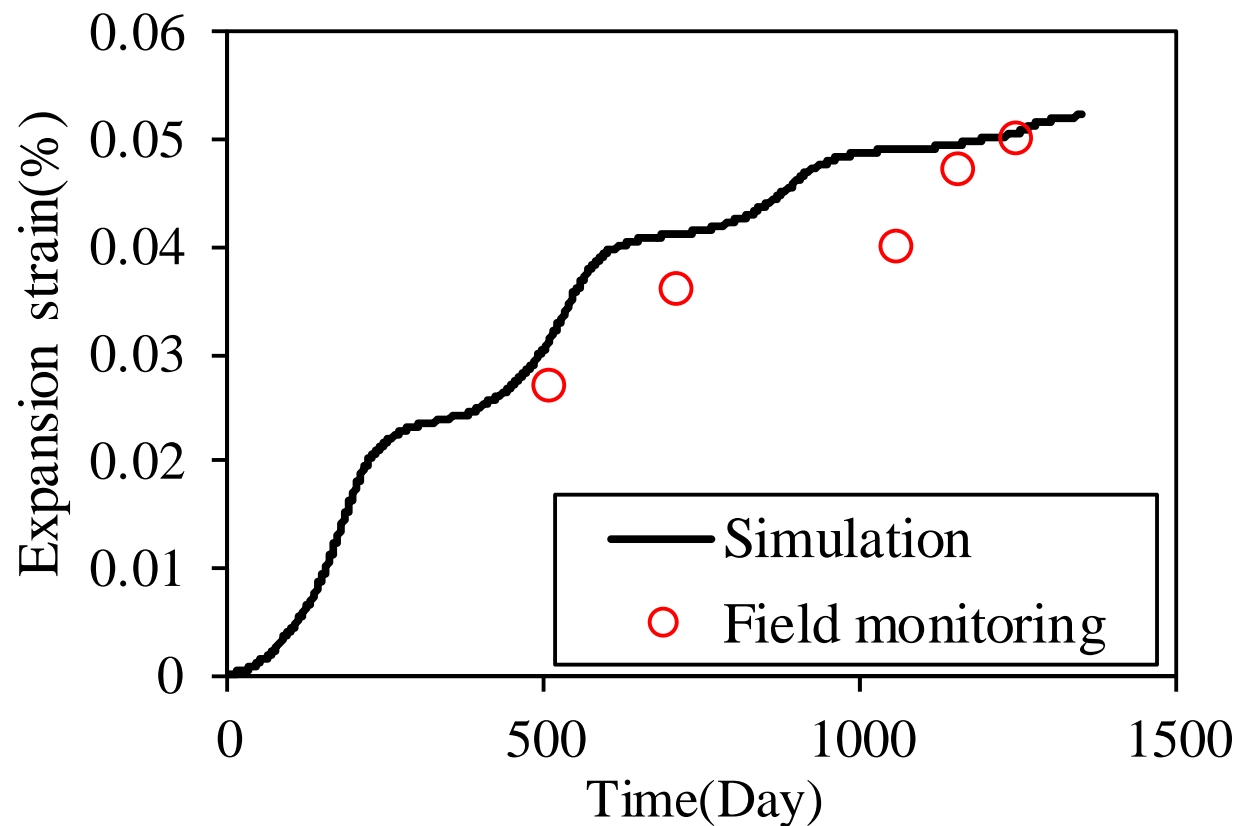
Simulation using the result of expansion test
(The model is following Kawabata)

- Simulation was well consistent with the result of expansion of field block
